# Fire Endurance of Open-Web Steel-Joist Floors With Concrete Slabs and Gypsum Ceilings

James V. Ryan and Edward W. Bender

Building Materials and Structures Report 141

Issued August 23, 1954

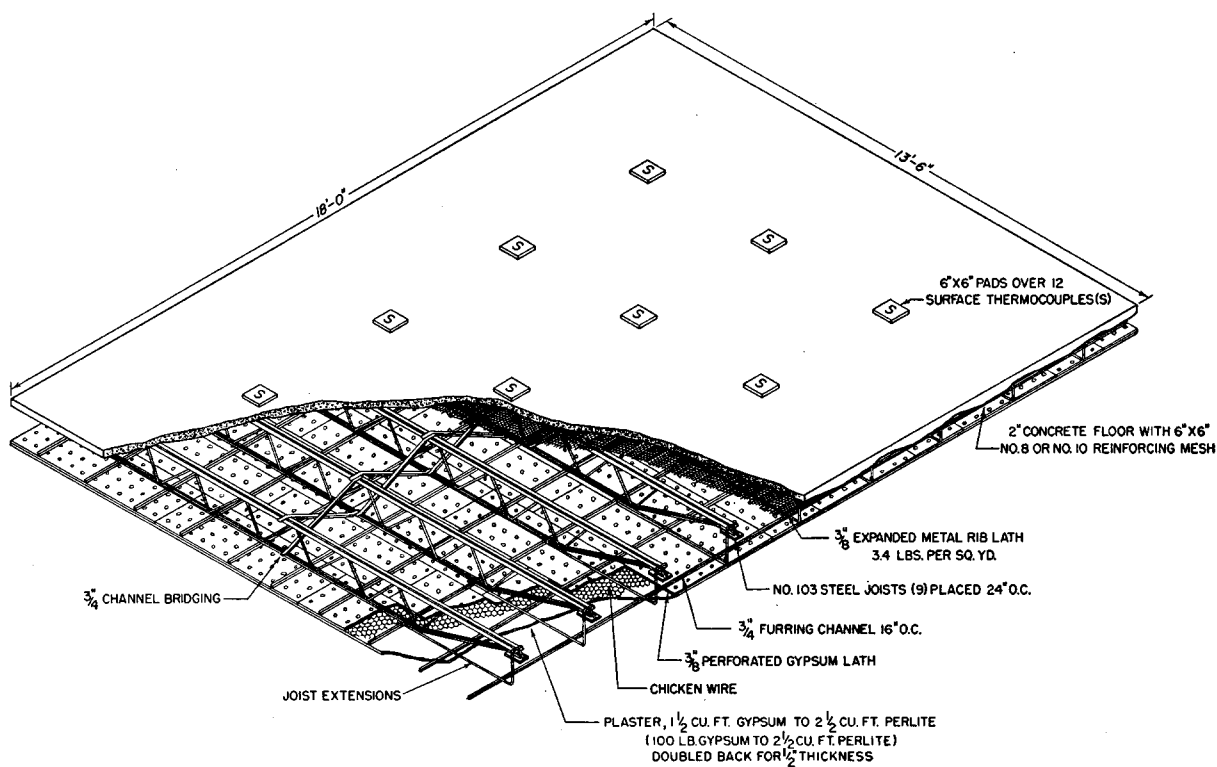
FIGURE 2. Construction details of specimen for test 312 with hexagonal-mesh wire reinforcing.

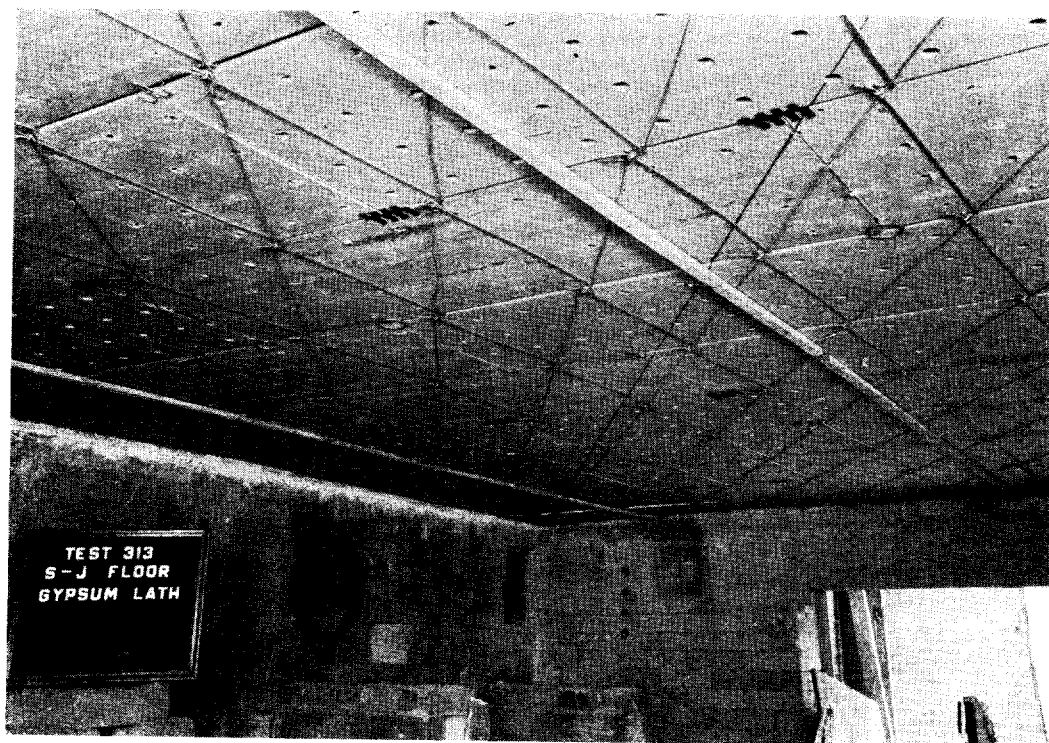
Figure 4 shows the diagonal wire support in place below the lath during the construction of test floor 313.

FIGURE 4. Lathed ceiling with diagonal wire reinforcing.

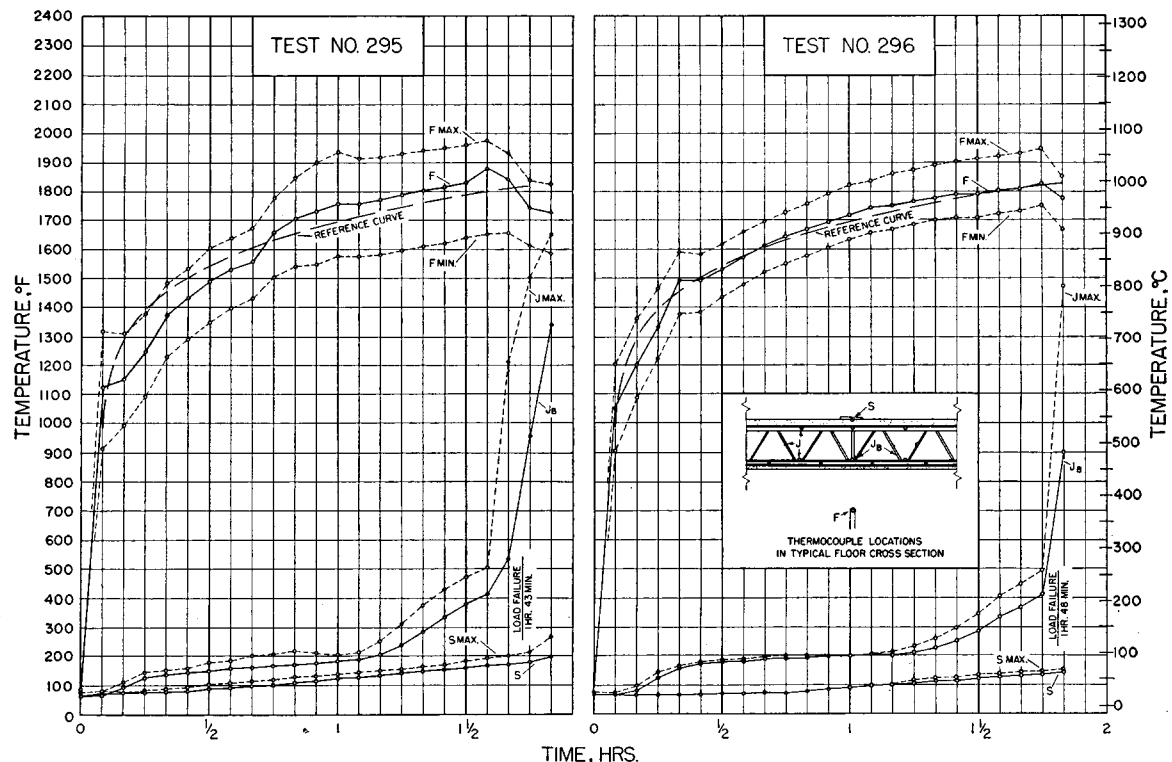
FIGURE 9. Time-temperature curves from tests 295 and 296, unreinforced ceilings.

In the tests of floors with ceilings in which the lath-clip systems were not supplemented by other reinforcing, progress from the end of the calcination period to load failure was rapid, with little difference noted for ceilings of the thicker plaster coats. Once the gypsum calcined, the lath and plaster cracked extensively and soon lost the strength necessary to support themselves. Portions of the ceilings fell, exposing the joists above directly to the hot flames and gases. These exposures resulted in high steel temperatures, loss of strength, and load failures.

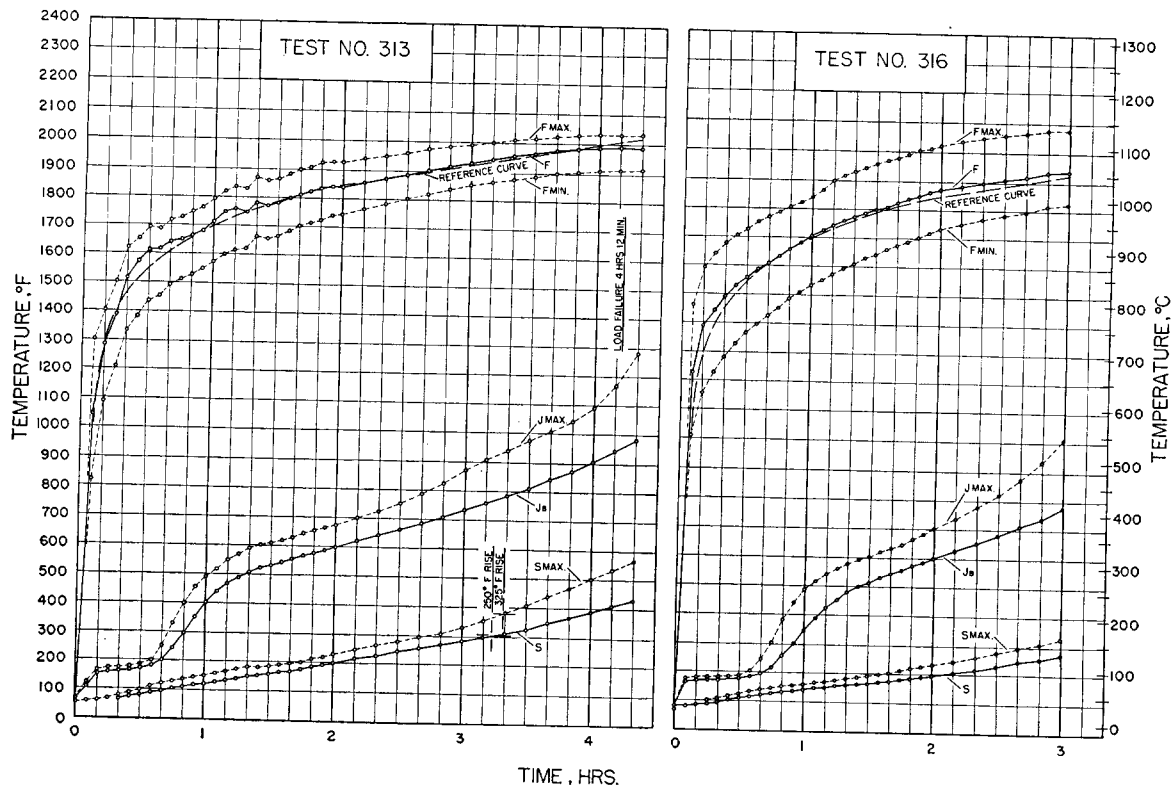
In contrast to the previously mentioned tests involving rapid load failure, the tests in which means were taken to prevent the breakup and fall of the ceiling indicated a slow rate of heat transfer through the ceilings and floors until the temperatures on top of the latter had been raised by the limiting 250 deg F average, or 325 deg F at one point. The means utilized to prevent the fall of the ceiling consisted of extra, more closely spaced supports for the lath so that much more

FIGURE 10. Time-temperature curves from tests 313 and 316, the former having a ceiling with diagonal wires and the latter one with extra clips.

breakup would be necessary before any pieces of lath and plaster were small enough to be unsupported. As long as the ceiling was kept in place, it continued to protect the joists and floor slab, even after the gypsum calcined. The joists were heated slowly and uniformly, yielding gradually into smooth curves rather than sharp buckles. In some cases, the joists were acting as suspension members by the ends of the tests.

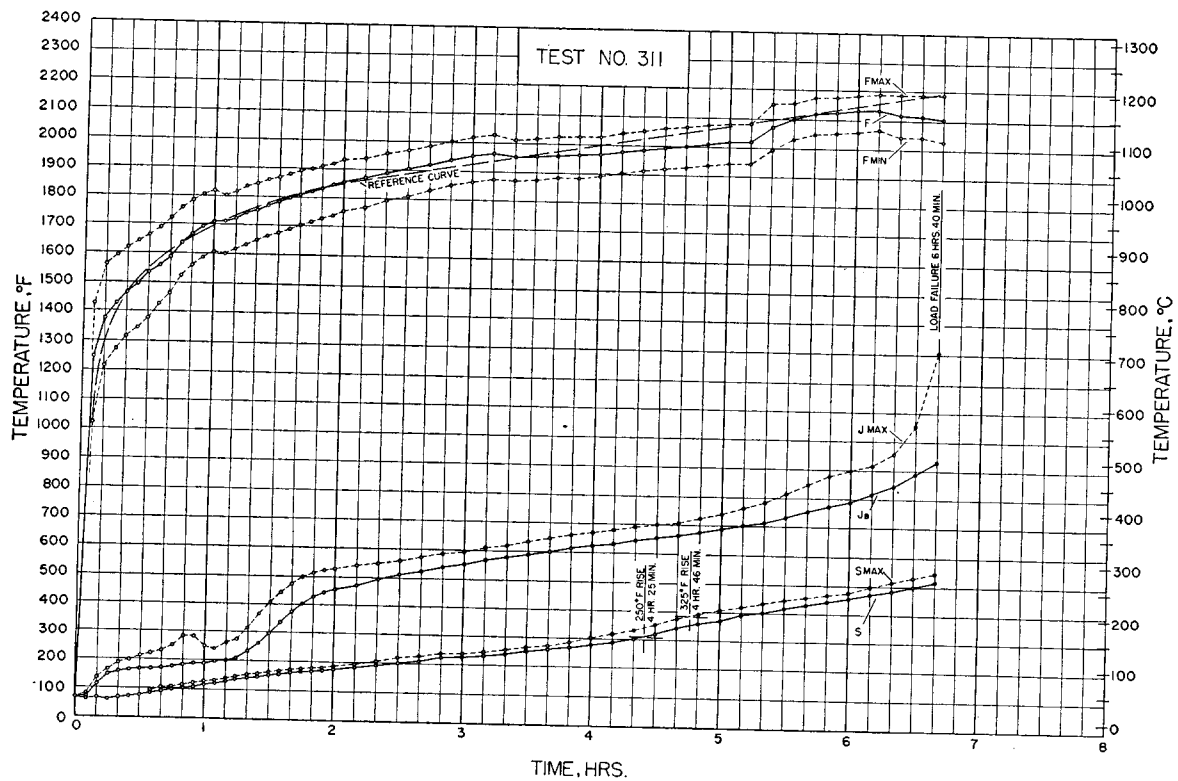
FIGURE 11. Time-temperature curves from test 311 having a ceiling with 1-in. hexagonal-mesh wire-fabric reinforcing.
